LASER ENGRAVING ALUMAMARK

What is AlumaMark?

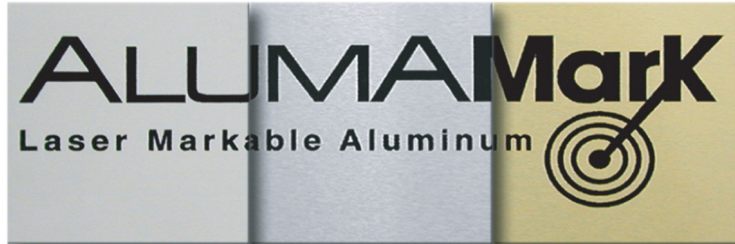
Optimal

The engraved area is shiny and dense black.

If the image you have engraved is a dense black color, then you have successfully engraved your design onto AlumaMark. You have reached optimal results and maximized contrast, resolution, and durability performance.

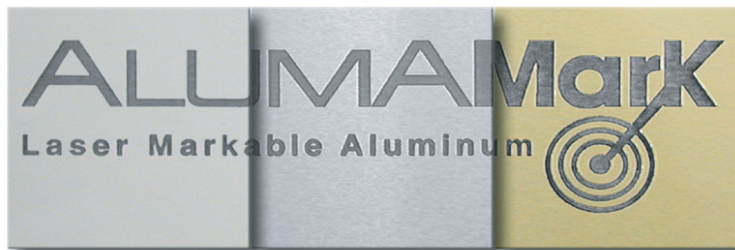
Over Mark

The result is a grayish mark with slight etching or relief. The marked area can look “flat” or matte especially when viewing at an angle. This is usually caused by an insufficient speed setting or a power setting that is too high.

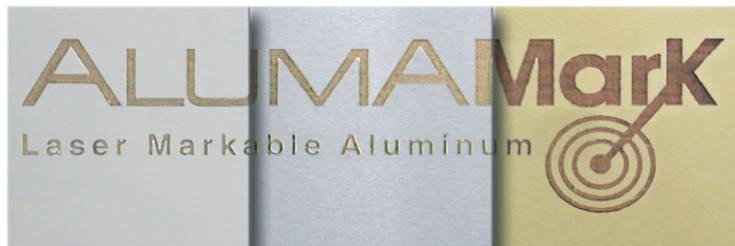
Under Mark

Under marking results in a brownish or faint image. Under marking can also cause inconsistency in the image as power is delivered unevenly to the AlumaMark. This is caused by too little power. These sheets can be lasered again with slightly more power until optimal is reached.
